Transformer failures in regions incorrectly considered to have low GIC-risk

C. T Gaunt, G. Coetzee

Index Terms— Power transformers, Failure analysis, Geomagnetically induced currents.

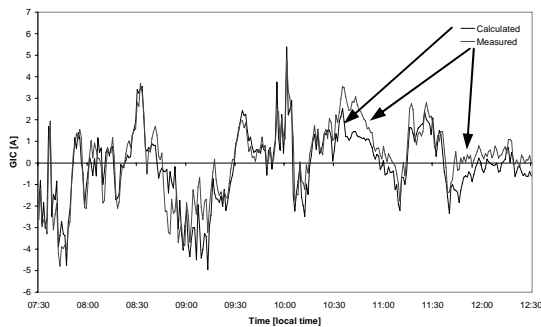
Koen [7] applied the approach developed by Lahtinen and Pirjola [8] to calculate the induced currents in the Southern African main transmission system (MTS), using the magnetic field changes measured at the Hermanus Magnetic Observatory (HMO). The calculations were based on a model that assumes a plane magnetospheric current and a homogeneous earth. Further, it assumed that the changes over large regions distant from the magnetic poles, such as over most of Southern Africa, are almost the same because the field change is dominated by the planar current [9]. The calculated results compared well with transformer currents measured in two MTS substations when geomagnetic storms occurred, as illustrated in Fig 2 [7]. In May 2005 a current of 13 A was measured at the Hydra substation.

Fig 2: 10 sec average values of calculated and measured GIC (in A) in the neutral of the 500 MVA autotransformer at Grassridge substation over five hours of storm on 31 Mar 2001 [7].

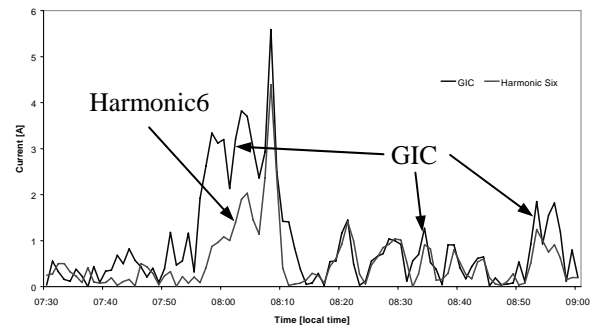
Half-wave saturation also increases the magnetising current and distorts the magnetisation current waveform [12]. The distorted magnetising current has harmonics that correlate well with the GIC, as shown in Fig 4, and indicate saturation.

Fig 4: GIC and 6th harmonic measured in the autotransformer at Grassridge substation on 6 November 2001 [7]
